W.O. #09-66504-0

Repair Lower Waterwall Tube-to-Header Welds in Unit 2

UDC
Outage Report
U-2 2010

Intermountain
Unit 2
Fall 2010

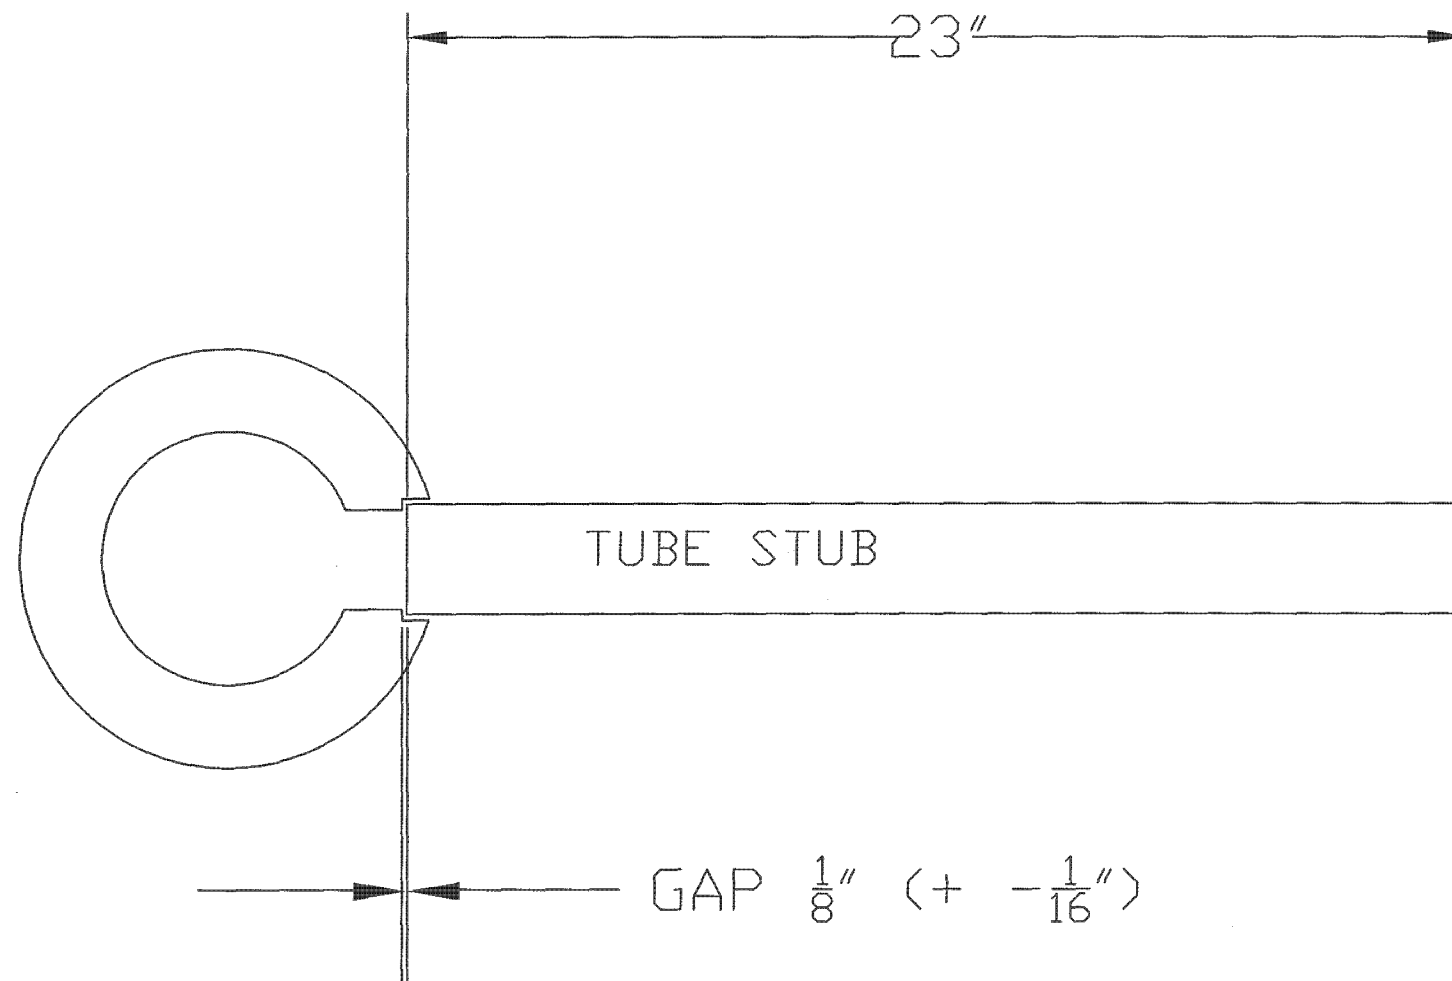
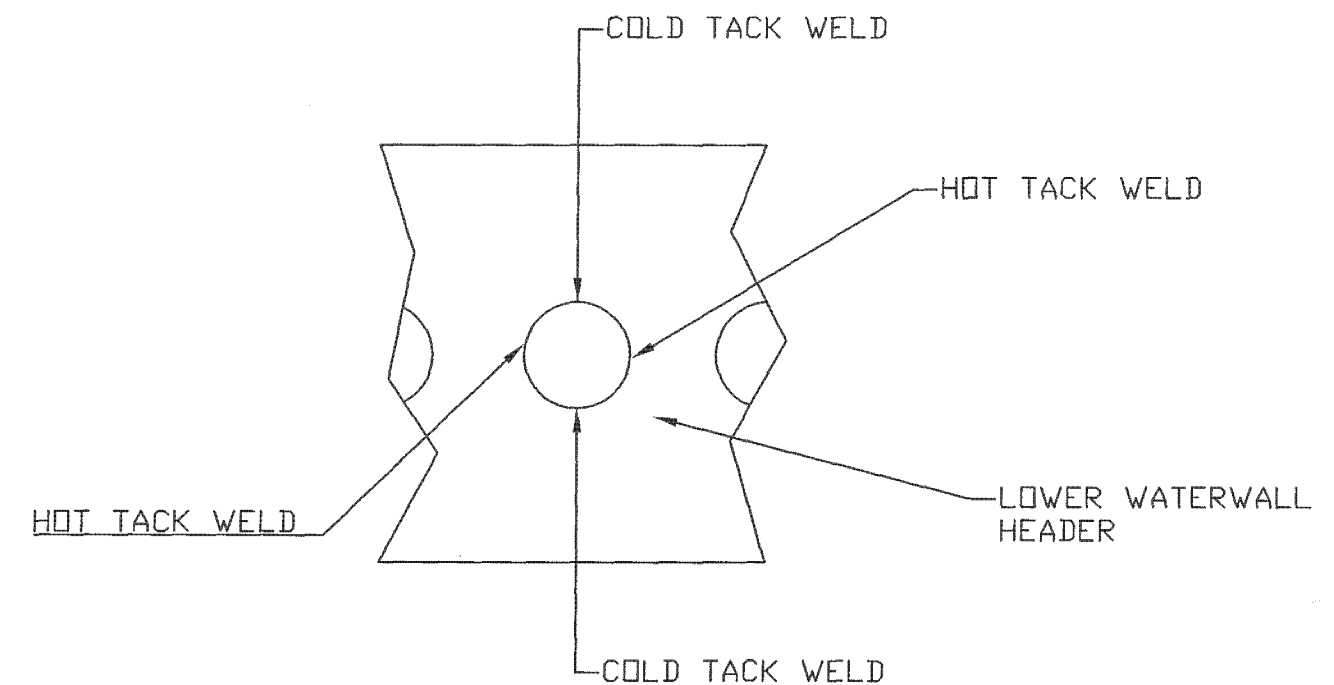
IGS09-11 BOTTOM ASH HEADER REPLACEMENT			
0 10-25-10				DRAWING NUMBER REV			
NO. DATE DESCRIPTION OF REVISIONS				1 0			
DGN CHK APP				INTERMOUNTAIN POWER PROJECT

TUBES TO BE CUT OUT & REPLACED
ARE ON HEADERS 6 & 7. MARKED
TUBES TO BE CUT OUT ARE ON HEADER
8. ALL TUBES ARE ON 3" CENTERS.
TUBES 38, 39, 40 & 42 WERE
REPLACED IN 2008 ON HEADER 7 (do
not replace). TUBE MATERIAL IS SA
210 A1 CF 2.5" OD X .270" MW.

BEVEL TUBES STUBS ON
NON-HEADER SIDE AT 37
1/2 DEGREES. BEVELED
ROOT FACE SHALL BE 1/16"
(- 1/16"). TIG WELD
STUBS TO EXISTING
BOILER TUBE & COVER
WITH STICK ELECTRODE.

1/8" ROOT GAP (+/- 1/16") TO BE
MAINTAINED BETWEEN THE HEADER
TUBE SOCKET BOTTOM AND TUBE
STUBS.

TACK WELD THE HEADER SIDE OF
THE TUBE STUBS ON THE TOP &
BOTTOM WHEN HEADER IS COLD.
PRE-HEAT HEADER TO 200 DEGREES
F. & TACK WELD TUBES ON EACH
SIDE. GRIND OUT COLD HEADER
TACK WELDS ON TOP & BOTTOM.
WELD TUBES TO HEADER USING A
3/8" MINIMUM SIZE FILLET WELD AND
STICK ELECTRODE.

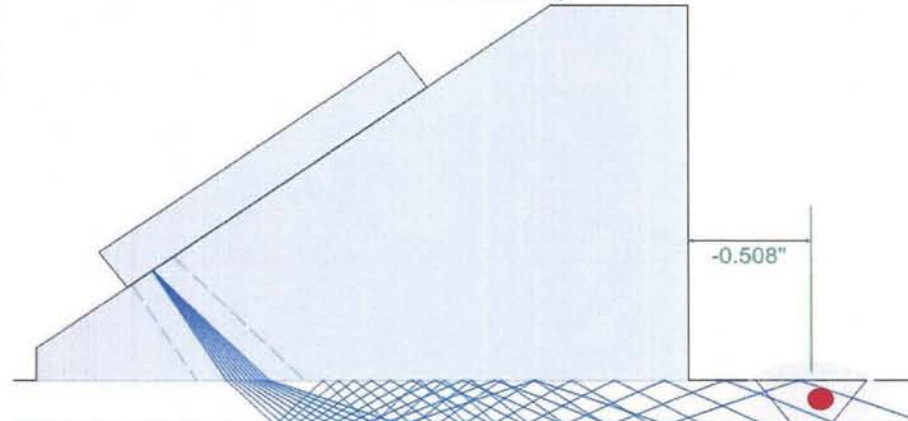
Header #	Tube #	Location	Weld pos.	Welder ID	Date Inspected	1st	2nd	3rd	Comment
6			tube	5174/6812	2-Nov	OK			
6	219	Front WW	header stub	5174/6812	5-Nov	OK			MT by 5 Star
6			tube	5174/6812	2-Nov	REJ	OK		Slag inclusion- repaired see FWW219AT & FWW219AB
6	220	Front WW	header stub	5174/6812	5-Nov	OK			MT by 5 Star
6			tube	5174/6812	2-Nov	OK			
6	221	Front WW	header stub	5174/6812	5-Nov	OK			MT by 5 Star
6			tube	5174/6812	2-Nov	OK			
6	222	Front WW	header stub	5174/6812	9-Nov	OK			MT by 5 Star
6			tube	5174/6812	9-Nov	OK			
6	223	Front WW	header stub	5174/6812	9-Nov	OK			MT by 5 Star
6			tube	5174/6812	9-Nov	OK			
6	224	Front WW	header stub	5174/6812	9-Nov	OK			MT by 5 Star
6			tube	5174/6812	9-Nov	OK			
6	225	Front WW	header stub	5174/6812	9-Nov	OK			MT by 5 Star
6			tube	5174/6812	9-Nov	OK			
6	226	Front WW	header stub	5174/6812	9-Nov	OK			MT by 5 Star
6			tube	5174/6812	9-Nov	OK			
6	227	Front WW	header stub	5174/6812	9-Nov	OK			MT by 5 Star
